TECHNICAL REPORT CERC-87-10

HURRICANE ELENA STORM SURGE DATA

Report 3

Coastal Engineering Research Center

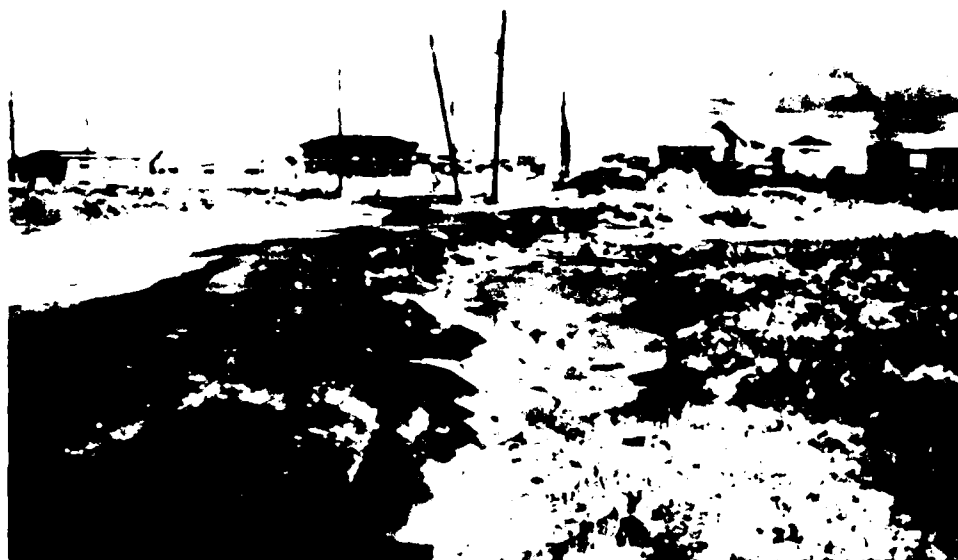
16. The hardest hit area on the coast was Dauphin Island, Ala., which was directly in the path of the hurricane's track just prior to landfall. There was extensive wind damage all over the island, but the majority of the damage caused by the surge was seen on the western half of the island where the surge passed completely over the island at a number of locations. This resulted in gulying which damaged roads (Photo 3) and undermined the foundations of houses (Photo 4). The high-water mark at these locations measured +6.5 ft NGVD. The small-boat harbor on the northeast side of the island suffered very little structural damage, but some of the boats were damaged or sunk when they broke free of their moorings (Photo 5). The only major surge-induced damage on the eastern end of the island occurred at Pelican Point where the deck of the wooden pier supporting the NOS/CE surge gage was destroyed (Photo 6). The high-water level at this location was about +6.7 ft NGVD with wave runup heights exceeding +8.0 ft NGVD.

Photo 3. Damage to road on north side of Dauphin Island,
looking west

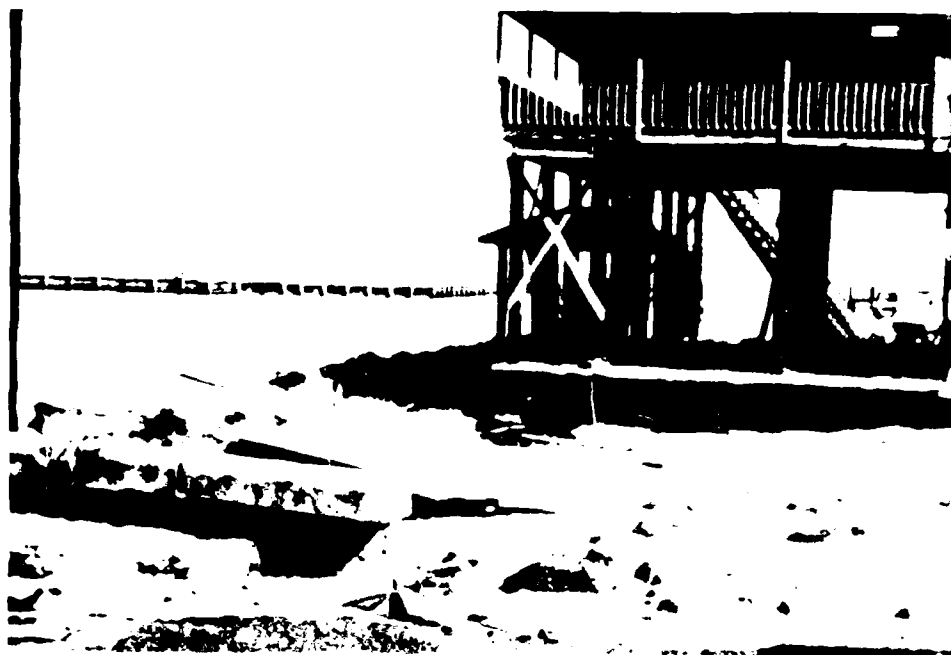
Photo 4. Foundation damage on the western half of
Dauphin Island, bay side

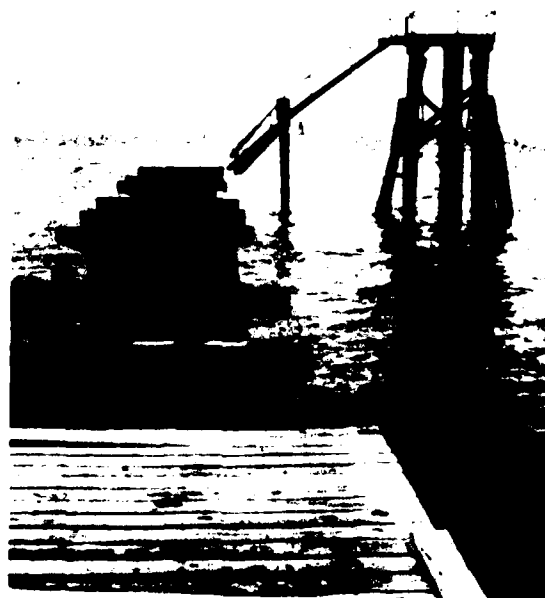
Photo 6. Pier damage at Pelican Point on the eastern end of Dauphin Island showing the NOS tide station where hydrograph of Dauphin Island (2) was obtained

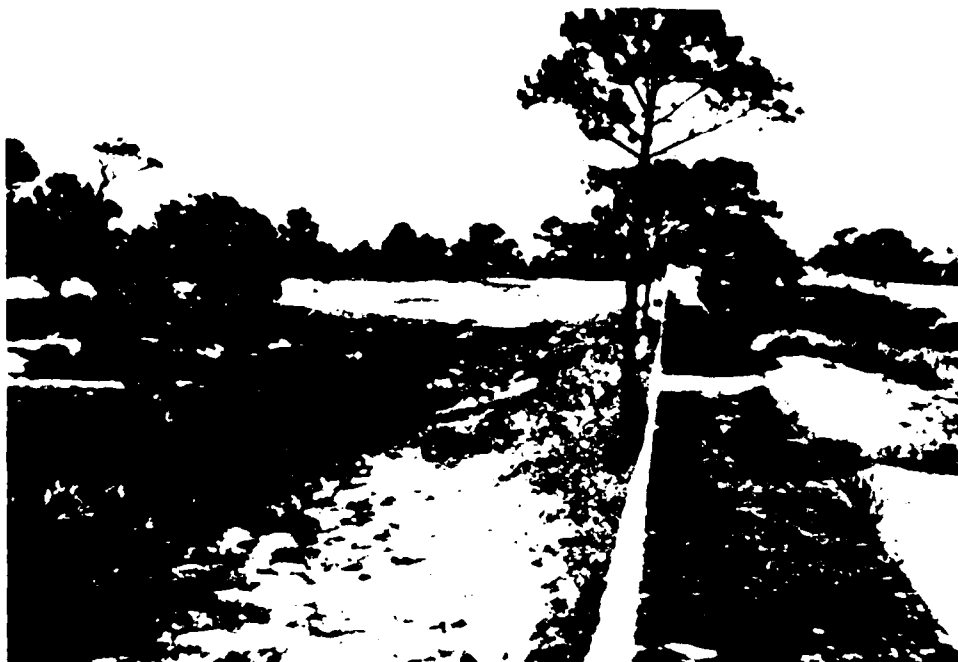
entrance to Mobile Bay exceeded +8 ft NGVD and reached the base of the seawall in Fort Morgan State Park (Photo 7). Within the boundaries of the state park, there were several locations where the surge passed completely over the spit, resulting in highway erosion (Photo 8). While surge related damage was confined to the highway, high winds totally destroyed one building and severely damaged several others in the park. Surge elevations dropped rapidly east of the park to an average of +4 ft NGVD. This was sufficient to cause some flooding in the communities located between the park and the city of Gulf Shores. However, the amount of structural damage was minimal as can be seen by the house shown in Photo 9.

Photo 7. Debris line at the foot of the seawall,
Ft. Morgan State Park, Ala., looking west

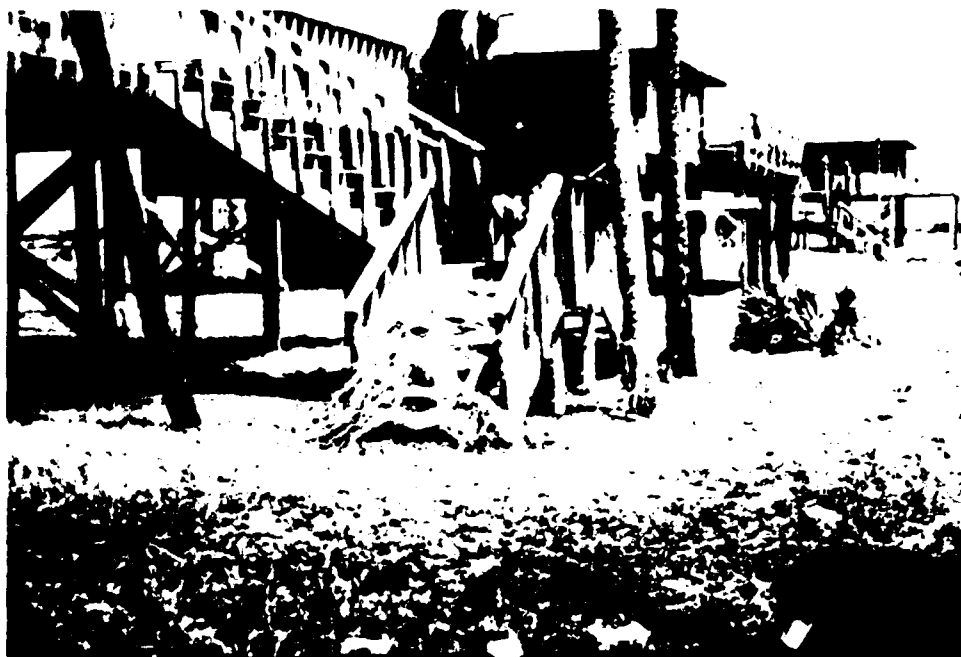
Photo 9. Debris line on house steps near Gulf Shores, Ala.

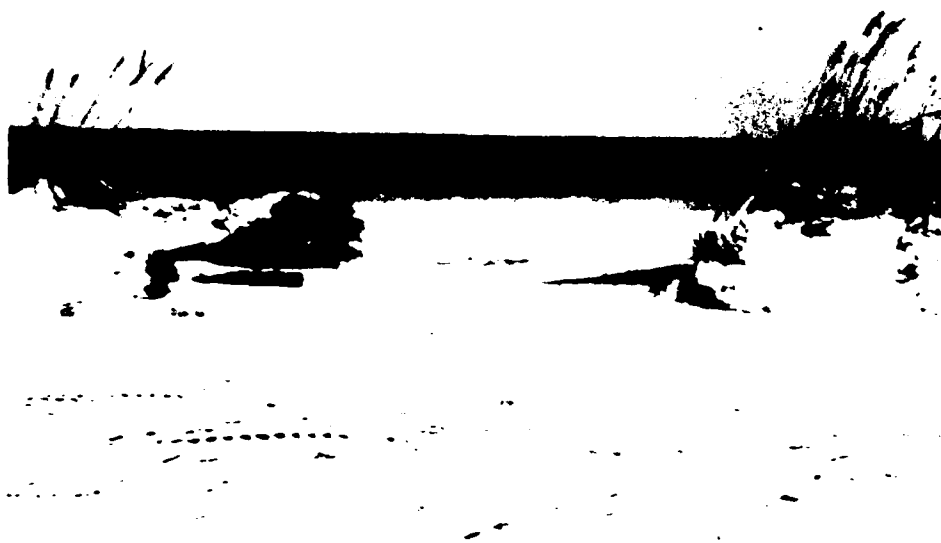
Photo 11. Cut through dune line in Destin, Fla.,
looking south

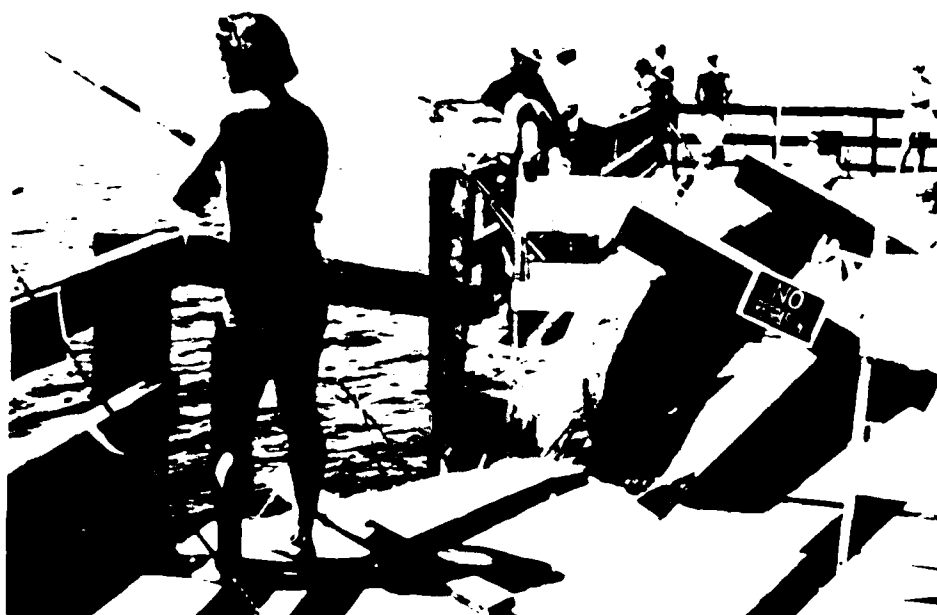
18. Throughout the western part of the Florida panhandle the measured high-water marks were less than +5 ft NGVD. Thus, actual damage resulting from surge was limited to minor highway damage and to structures located very close to the high-water mark such as the chain link fence in Pensacola Beach shown in Photo 10. In Destin, the surge and wave runup cut through a dune line (Photo 11) and flooded a lagoon located behind the dune line. The water level in the lagoon rose approximately 5 ft but did not flood any of the structures surrounding it. Farther east along the coast, surge levels continued to diminish with most high-water marks at an elevation of less than +4 ft NGVD. However, some damage did occur at several locations. One such location was the Dan Russell City Pier in Panama City Beach, Fla. The concrete decking on the end of the pier was lifted and broken by waves (Photo 12). This damage occurred at an elevation of approximately +20 ft NGVD, at a location where the measured wave runup did not exceed +10 ft NGVD, and is probably the result of the seaward end of the pier being in the breaker zone during part of the storm.

Photo 12. Damage to the decking of Dan Russell City Pier at
Panama City Beach, Fla.
